**FINAL  
SITE INSPECTION REPORT  
INTERNATIONAL METALLURGICAL SERVICES  
NEWARK, NEW JERSEY**

**CERCLIS ID No.: NJD982273559**

May 28, 1993

**ROY F. WESTON, INC.**  
Raritan Plaza I  
4th Floor  
Raritan Center  
Edison, New Jersey 08837

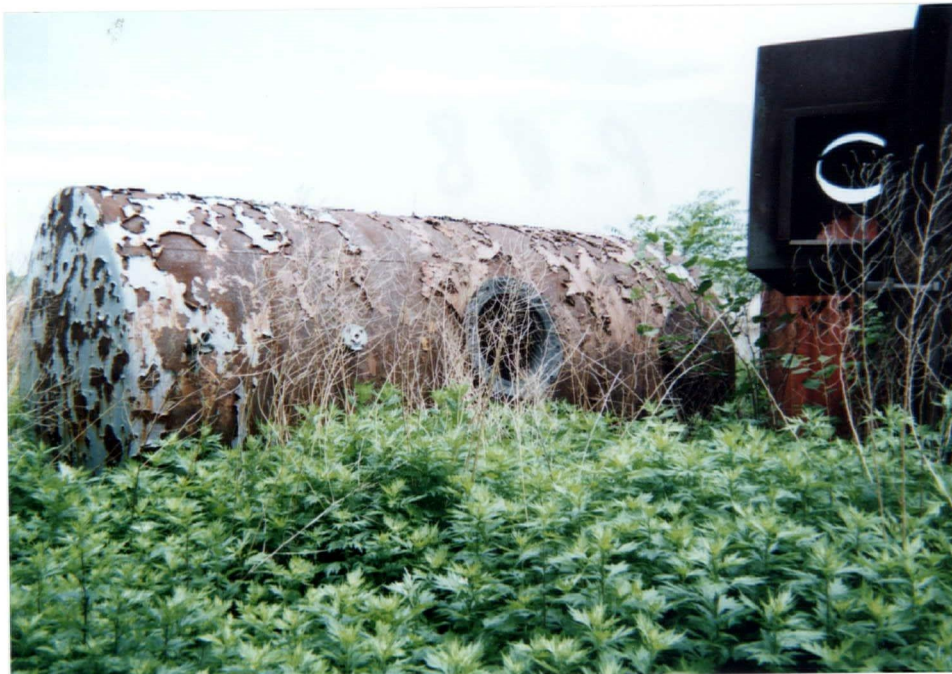
1P-8

Looking north at the tank located just west of the shipping containers.

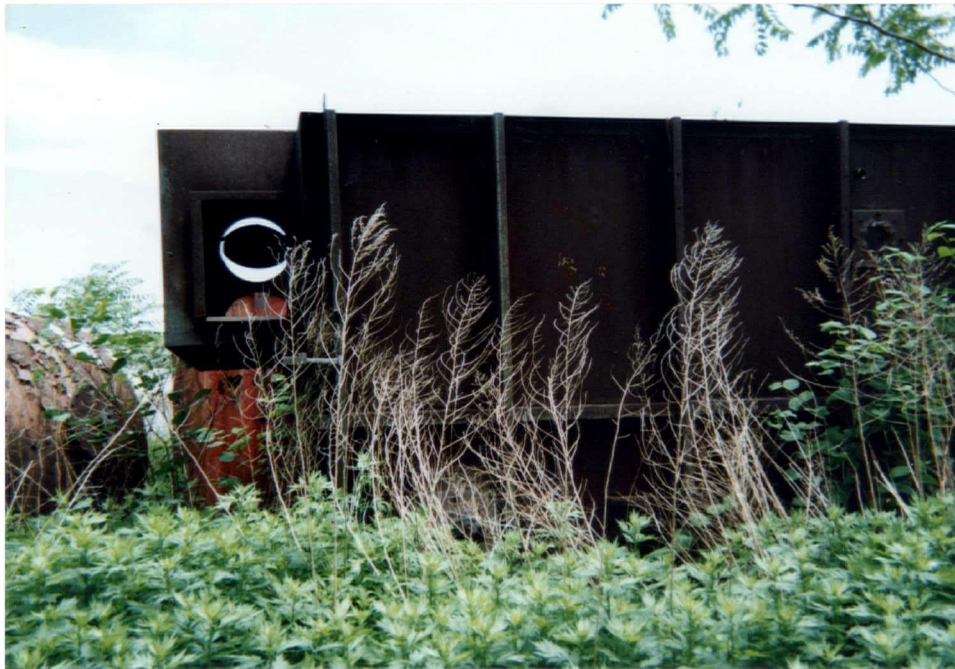
1P-9

Two 20 cubic yard shipping containers (no additional descriptive information available) were located in the northern portion of the site. A 1987 NJDEPE memorandum noted that one container was empty, while the other contained scrap circuit boards and two drums of unknown material. These wastes were presumably removed with all of the other waste shipped off site, the last of which was shipped in July 1989. Since it was taken from the site to an approved facility prior to the date of this site inspection, the removal meets CERCLA eligibility.

Looking north at the shipping containers.

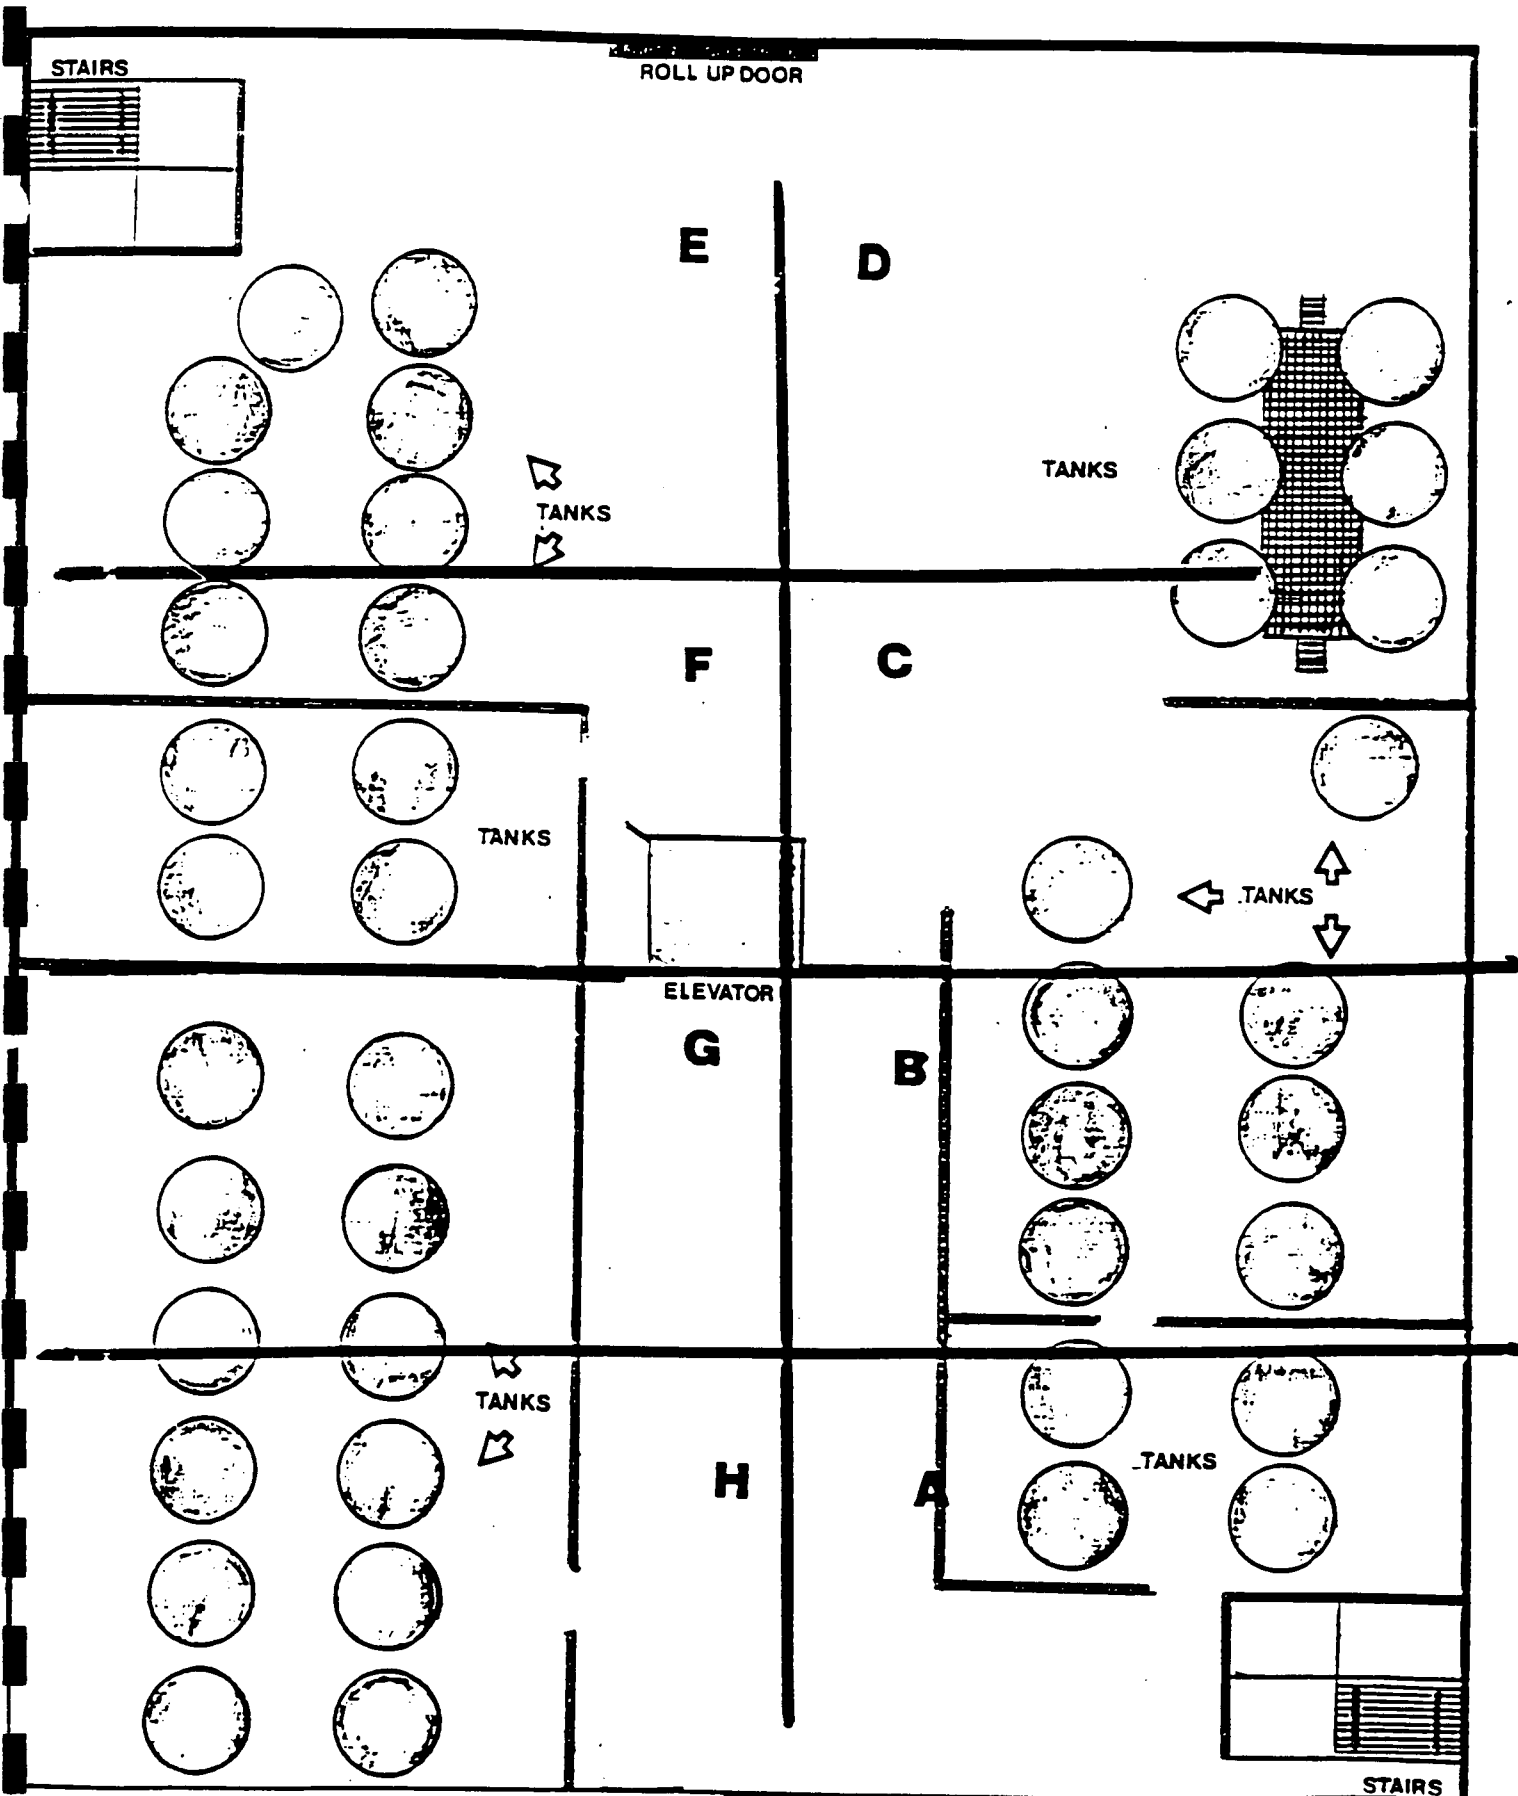
EPA PM	JOHN SHAW	THIRD FLOOR
TAT PM	DAVE TRIGGS	FIGURE 6

The third floor is divided into two walled off areas and one partially walled off area. Rows of empty tanks ranging in size from 5,000 gallons to 8,000 gallons occupy all three areas. Containers ranging in size from 5 gallons to 55 gallons were found in a corridor that separates the two main

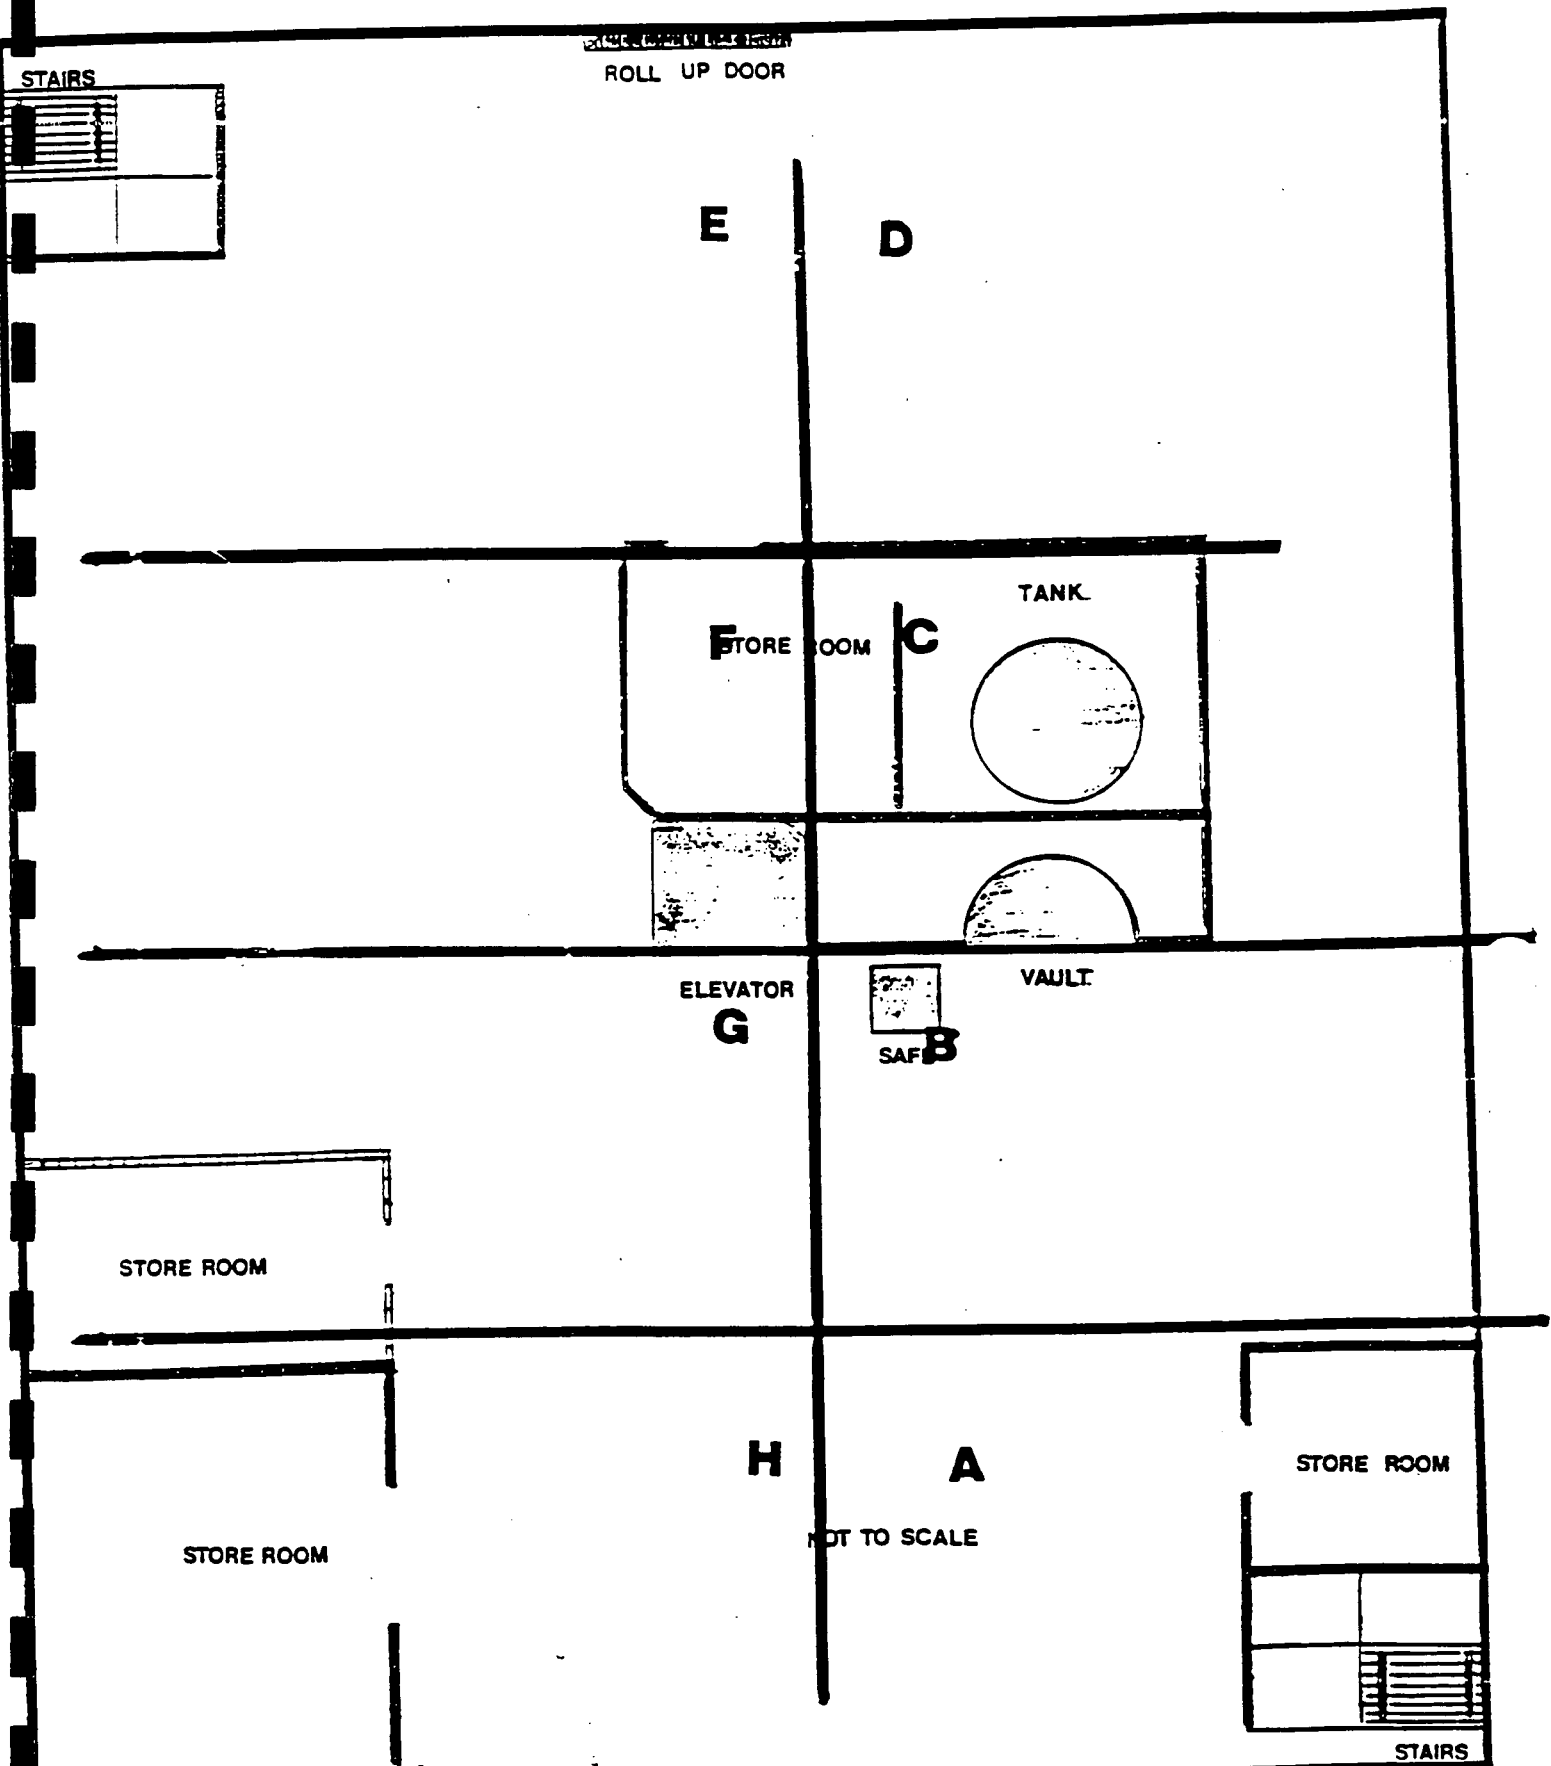
EPA PM	JOHN SHAW	FOURTH FLOOR
TAT PM	DAVE TRIGGS	FIGURE 7

The fourth floor is divided into three walled off areas. Two of the areas make up store rooms, one located on the northwest corner of the building and one on the southwest corner. The third area is located roughly at the center of the floor, houses a single empty tank. A small caged off area connects to the tank room, as well as a large vault used to store bars of gold and silver during the facilities operation. Another caged off area located next to the northwest store room was found littered with many containers and laboratory reagents ranging in volume from one ounce to thirty gallons. The containers were found piled haphazardly amongst paper and other miscellaneous debris. Labels and/or markings on some of these containers indicated that they may have contained phenols, vanadium pentoxide, sulfurous acid, mercuric iodide, ethyl acetate and pyridine. A diagram, Figure 3, lists the toxicity of some of the substances mentioned.
